The Professional Manual of Chemical D.P.C. Injection

Rising Damp

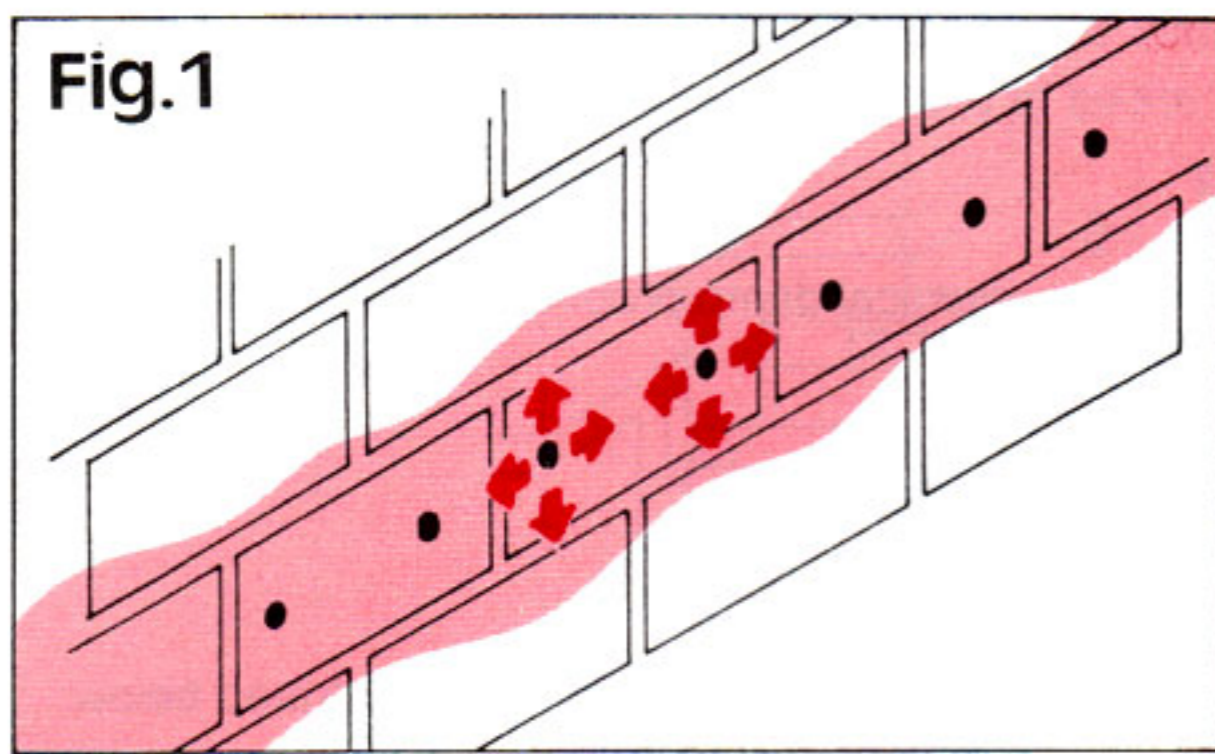
No. of holes/brick. Fig. 1

2 holes/brick are normally recommended. If the brickwork is particularly dense, 3 holes/brick may be required to equalise the distribution of the fluid thereby achieving total saturation of the selected brick course.

1. High pressure injection of the main fabric of the building, ie., individual brick or stone: see Fig. 1. and Fig. 1a.
2. Low pressure injection leading to the total envelopment of the main fabric of the building via saturation of the jointing medium: see Fig. 2. and Fig. 2a.

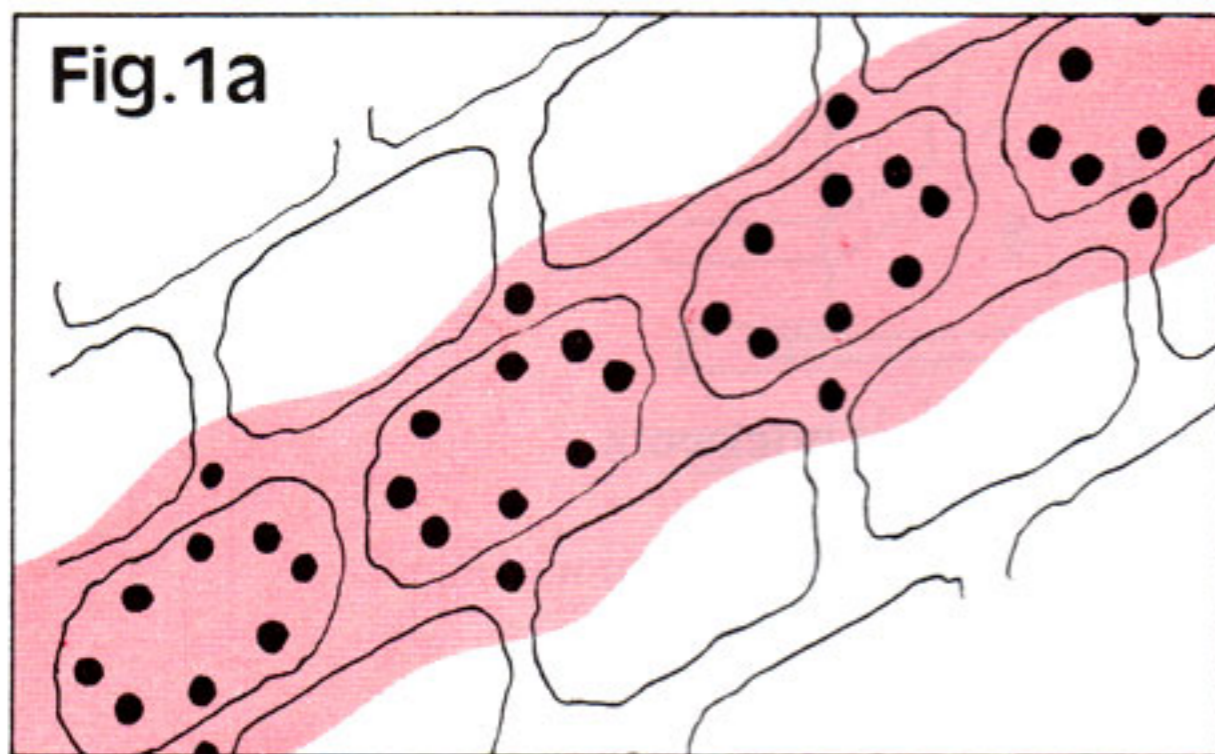
Fig. 1a

It is not important that the centre of dressed stonework is fully saturated. It is important that the entire individual stone be enveloped in injection fluid together with surrounding mortar joints.

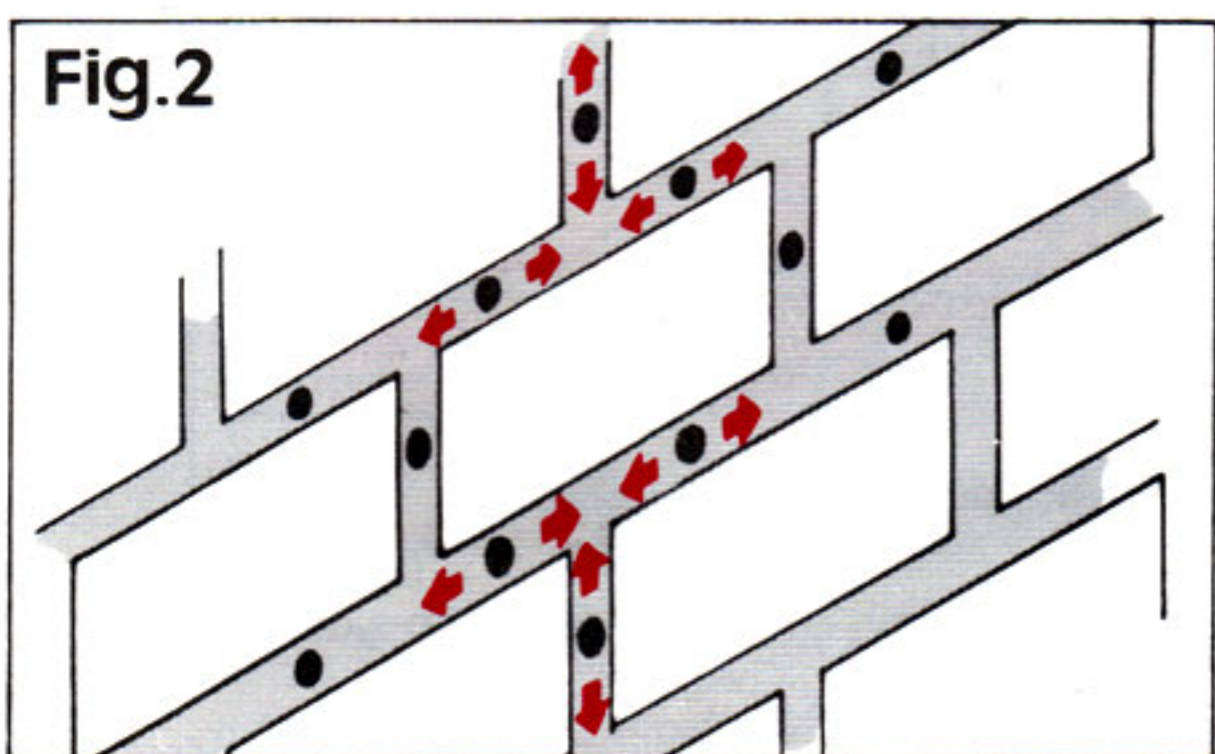
Fig. 2. Dense brickwork

Some bricks, eg. engineering, blue bricks etc., often do not allow the passage of water, yet rising damp still occurs. It will be found that in these cases the moisture is rising through the mortar joints. The density of the construction of this brickwork will not normally allow good saturation by injection. In these cases it is permissible to inject the surrounding mortar joints.

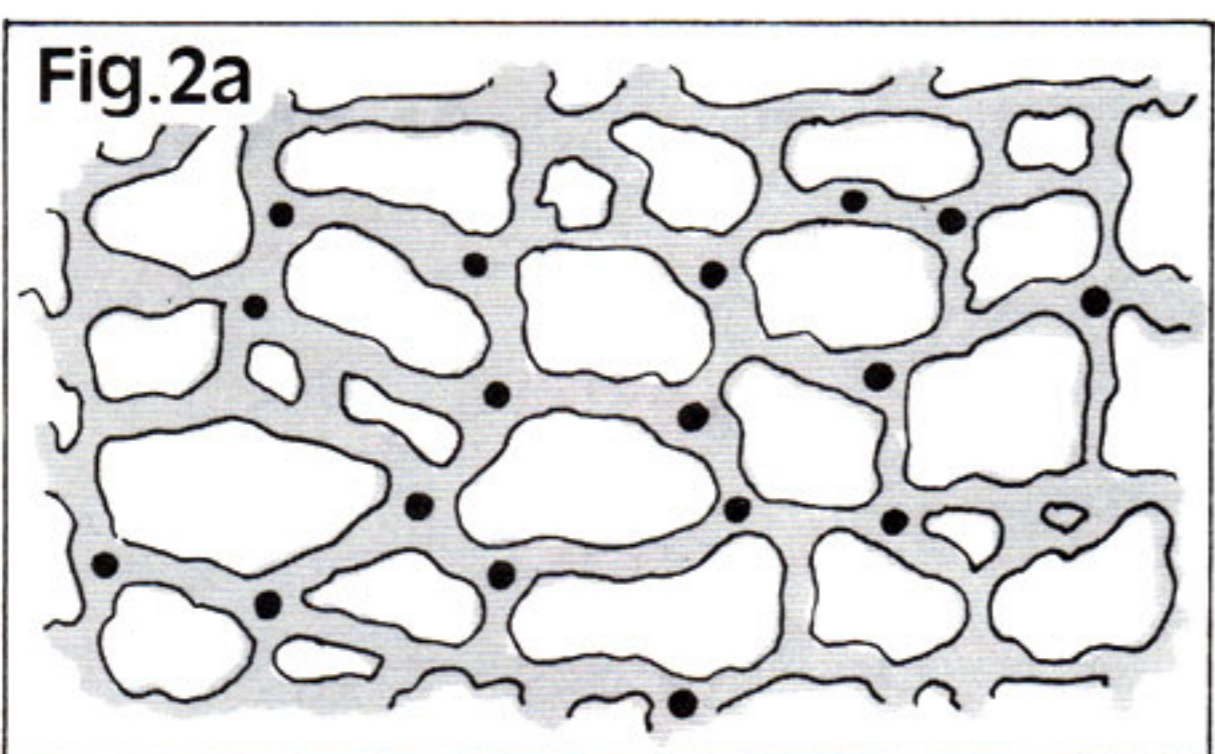
Random stone walling. Fig. 2a.

Random walling is usually composed of rubble and mortar to a degree greater than that of individual stone. In these cases greater efficiency will be obtained by flooding the mortar and rubble as illustrated. This applies particularly if the stone itself is non-porous, ie., granite, flint or slate, but damp is rising through and between the mortar joints.

A much lower injection pressure is employed for this method.

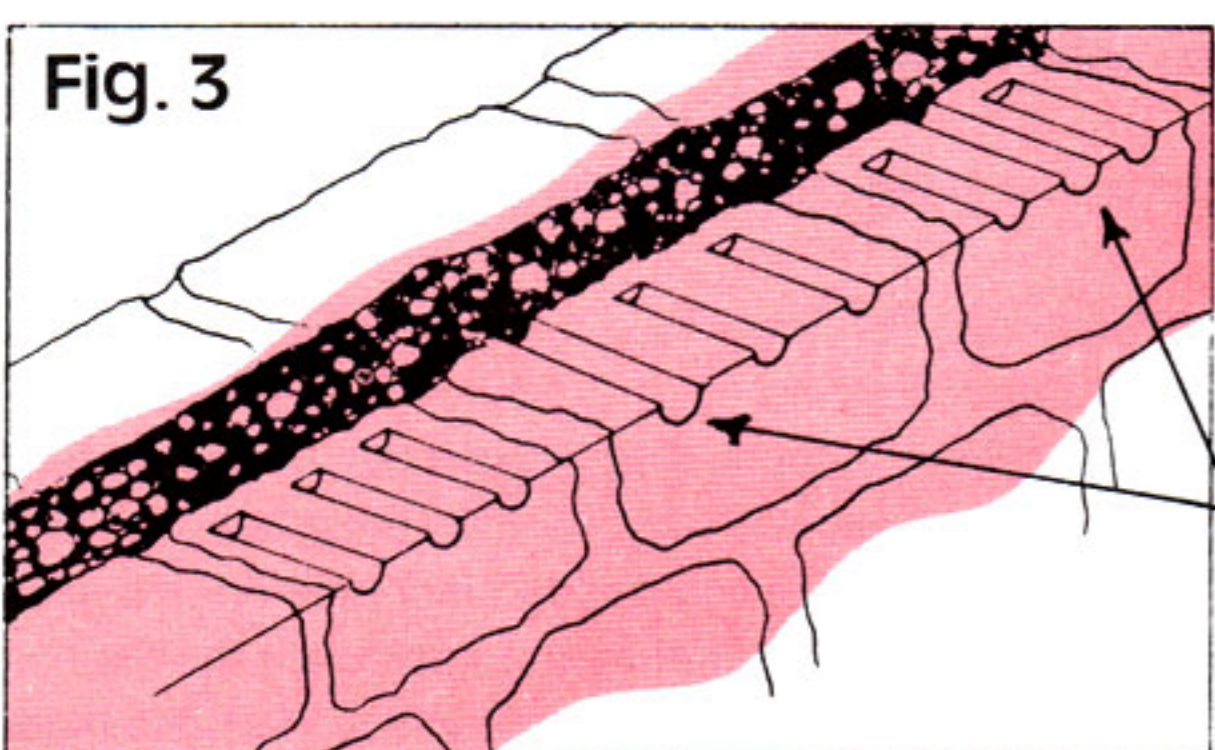
Fig. 3

Holes to show where injection has taken place directly into the rubble infill to ensure complete saturation.

Note! Every fifth hole is extended through the main fabric into the rubble infill.

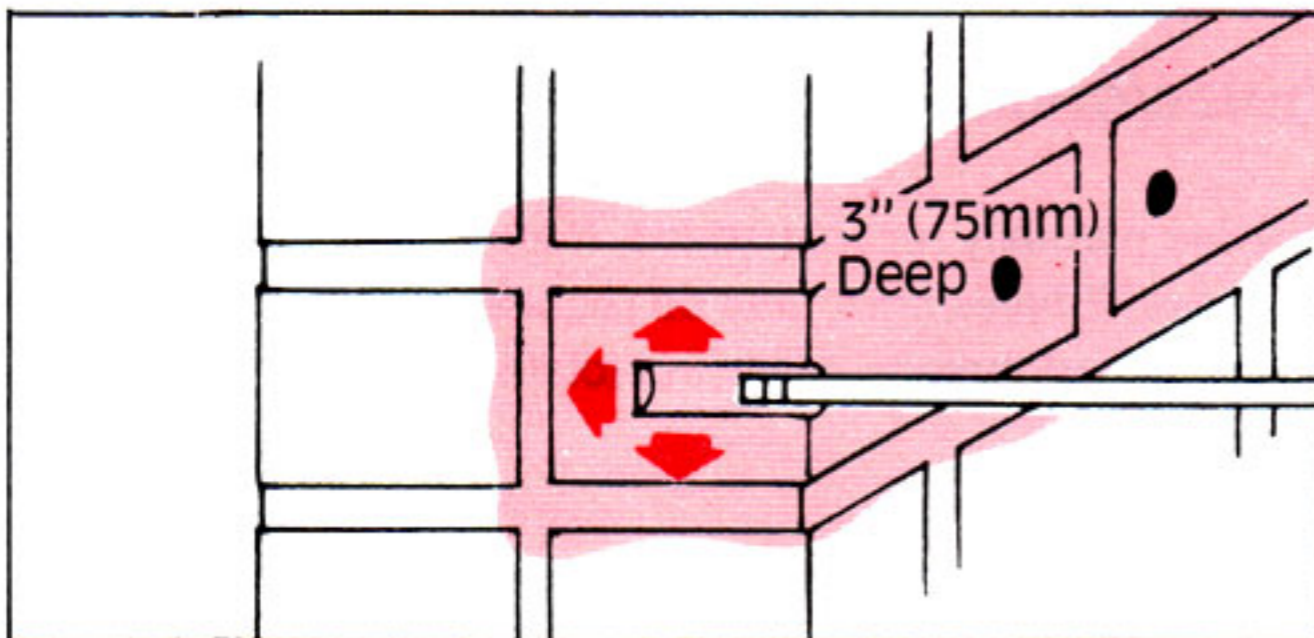
4 1/2" (115mm) single leaf brickwork

Drill the brick to a depth of 3" (75mm) and inject.

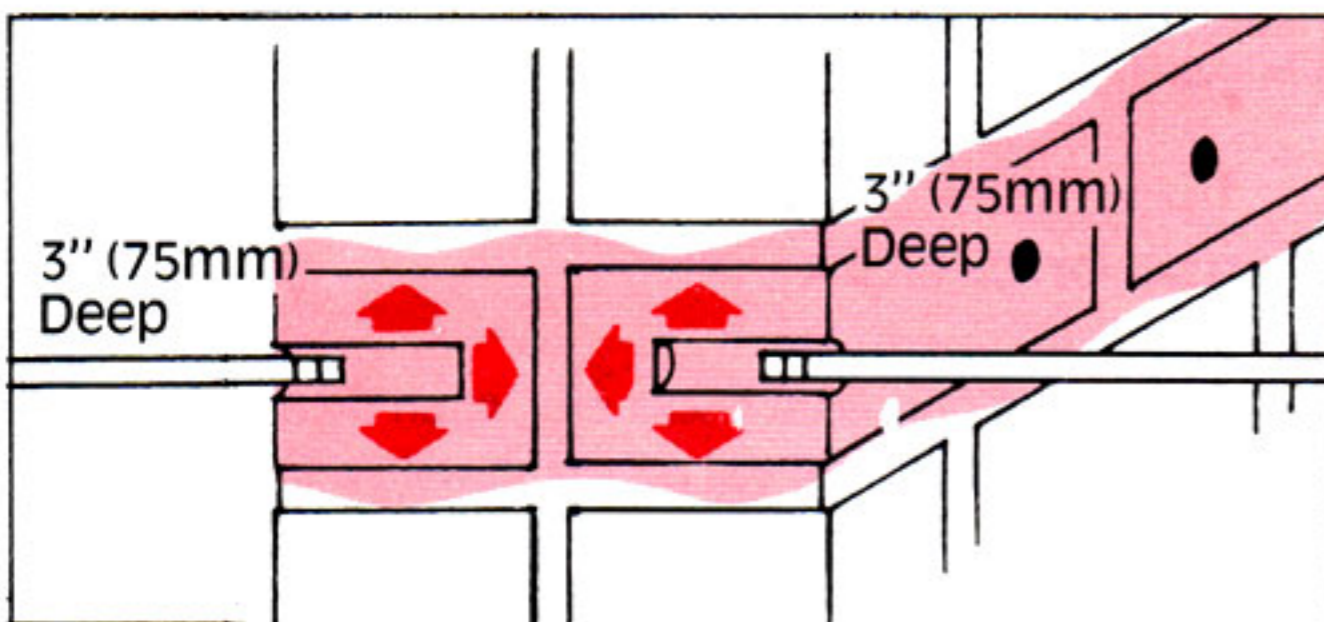
9" (230mm) solid brickwork - two sided

Method as 4 1/2" (115mm). Drill and inject both sides.

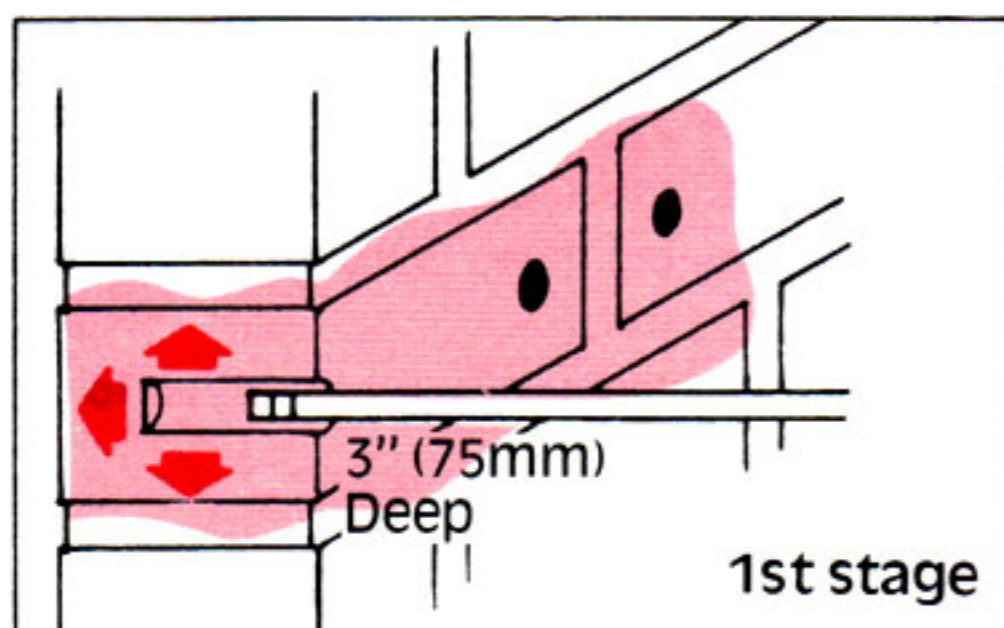
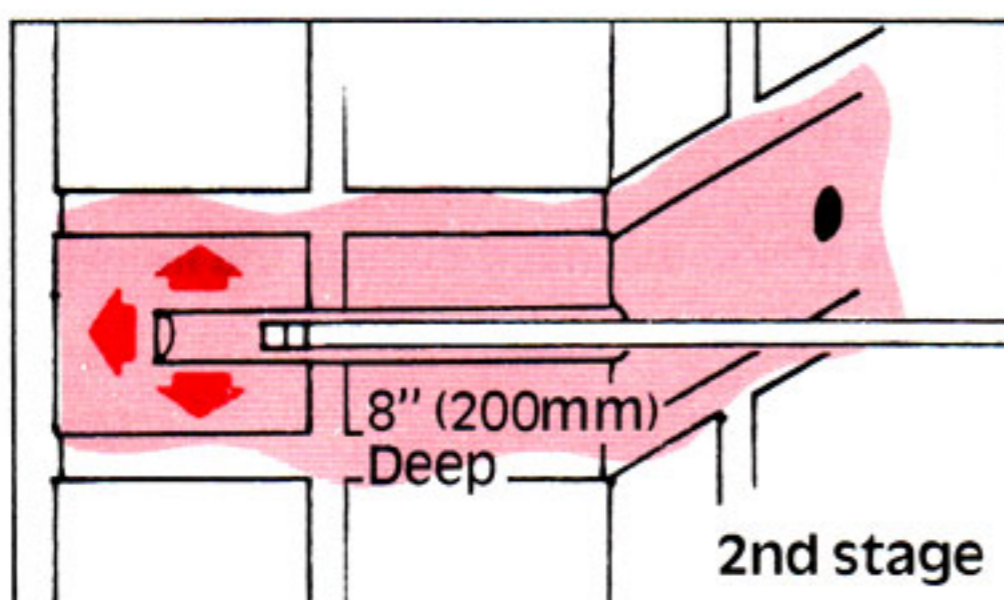
9" (230mm) solid brickwork - one sided

Explanation for one sided drilling and injection.

1. Drill 3" (75mm) into first leaf.
2. Inject to saturation first leaf.
3. Re-drill same hole to a depth of approximately 8" (200mm) (an extra 1/2" (12mm) is allowed here for the space between the abutting walls). Insert injection rod through first hole and couple into new drilled hole and inject; it is important to calculate the time injection takes on the first leaf to determine injection on the hidden side of the brickwork.

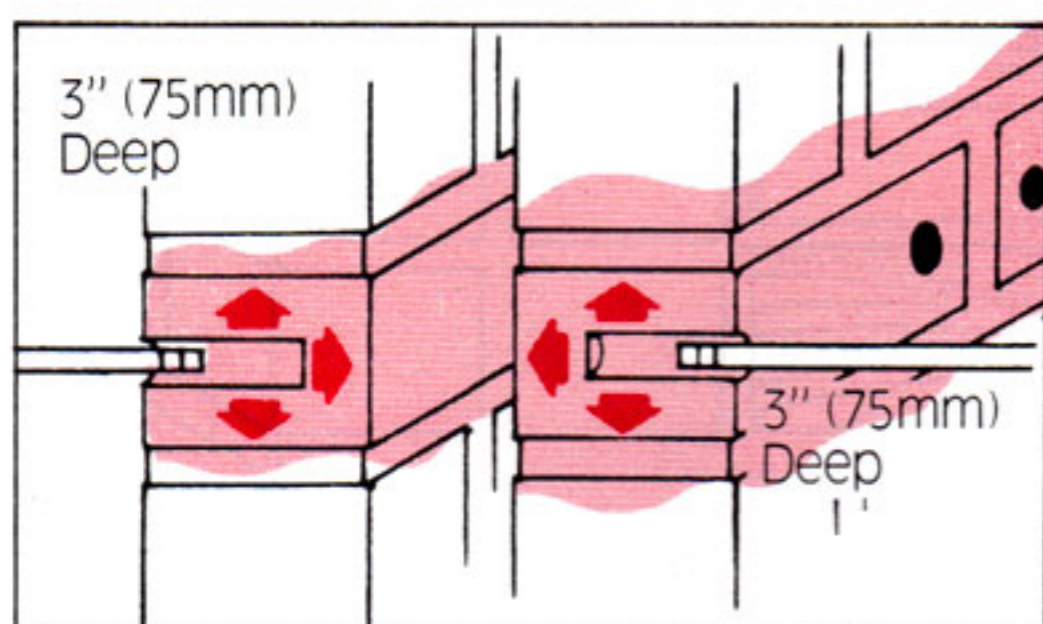
9" (230mm) cavity brickwork - two sided

Drill and inject both sides

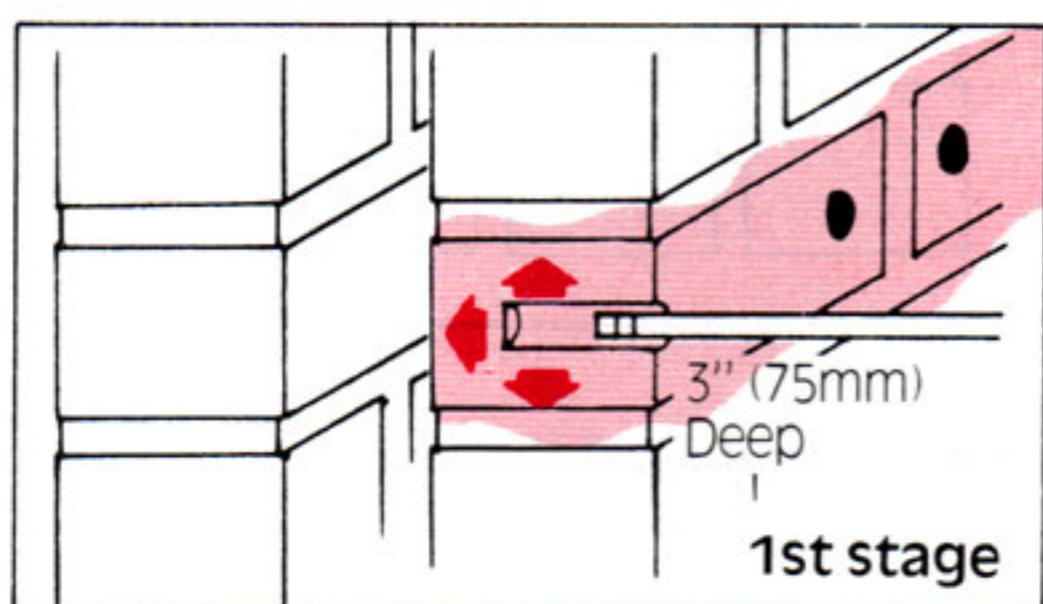
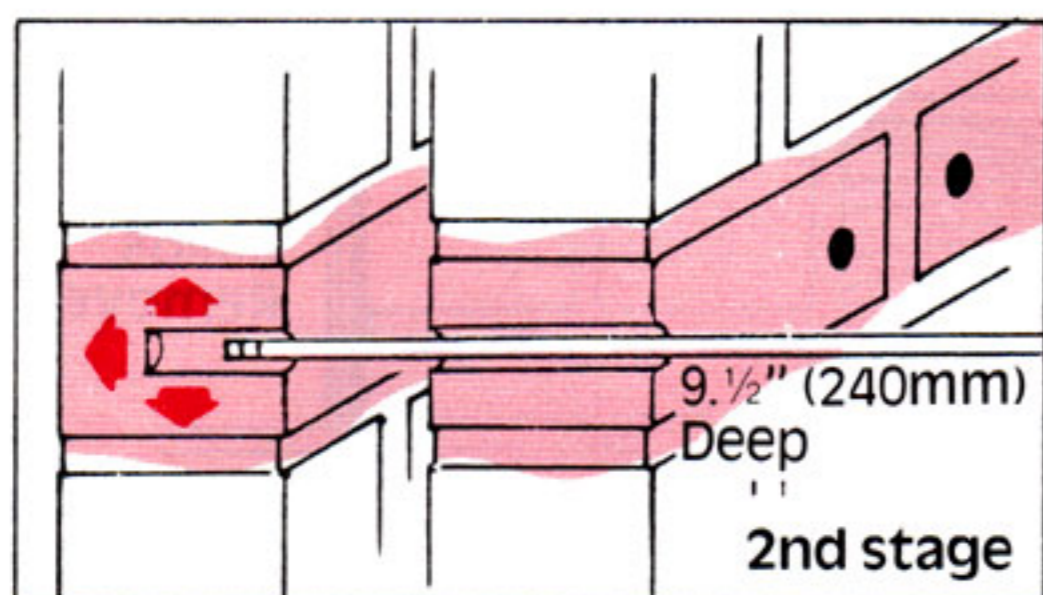
9" (230mm) cavity brickwork- one sided

1. Drill 3" (75mm)

2. Inject to saturation first leaf.

3. Re-drill same hole to a depth of 9 1/2" (240mm). Insert injection rod through first hole and couple into new drilled hole and inject; it is important to calculate the time injection takes on the first leaf to determine injection on the hidden side of brickwork. When double drilling it is advisable to redrill the first hole at a greater diameter to facilitate easy removal of injection rods from the second leaf.

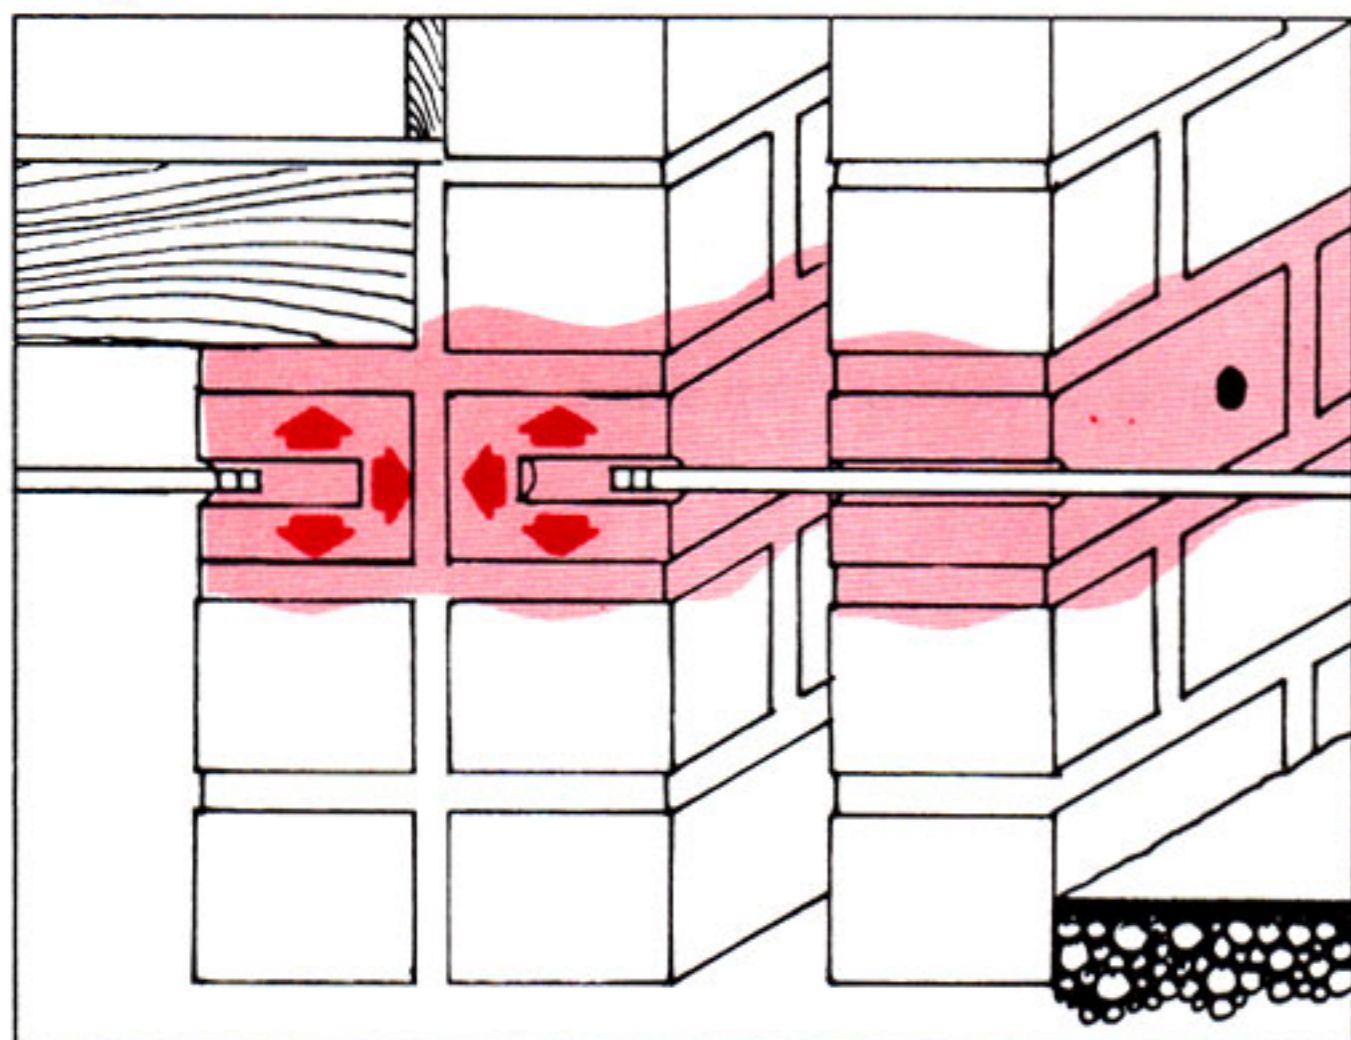
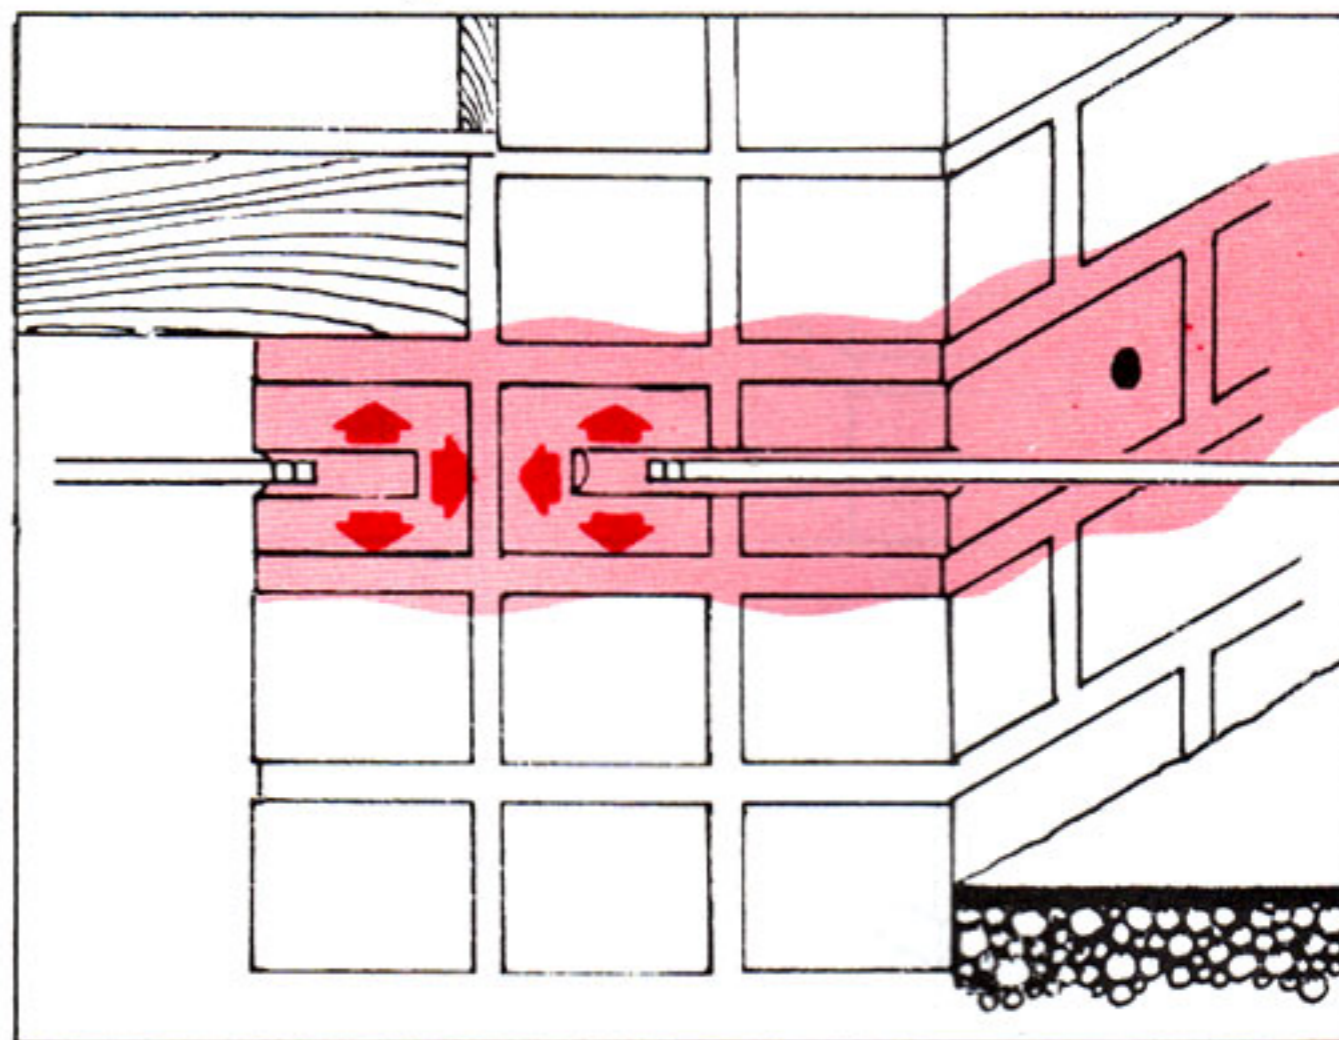
External ground level is below internal floor level.

The above diagrams illustrate the most acceptable positions for a chemical damp course under varying conditions.

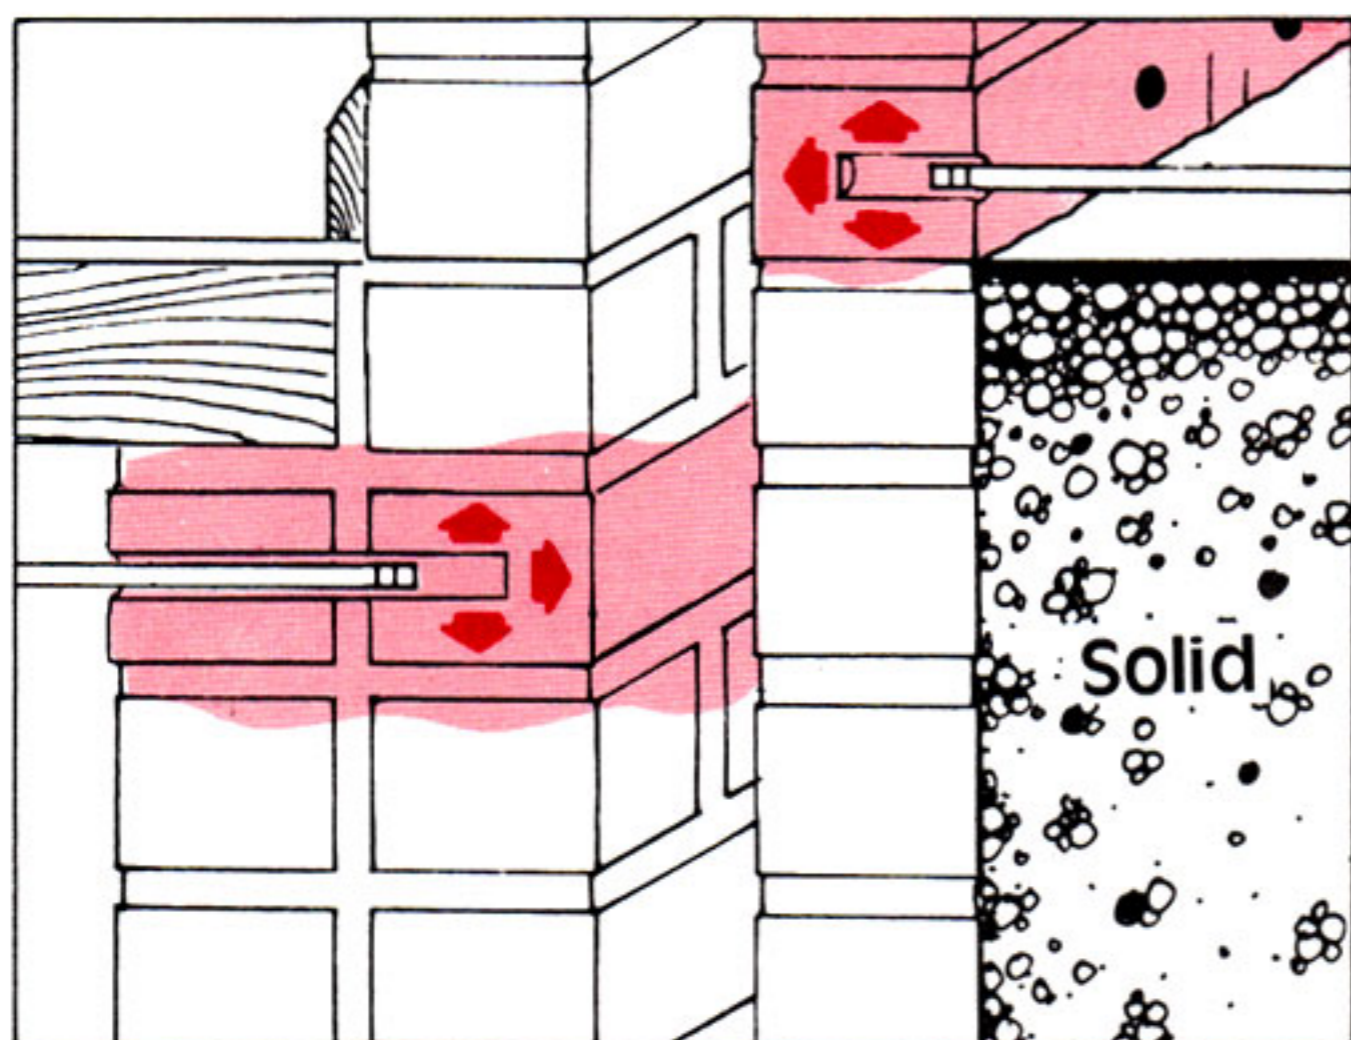
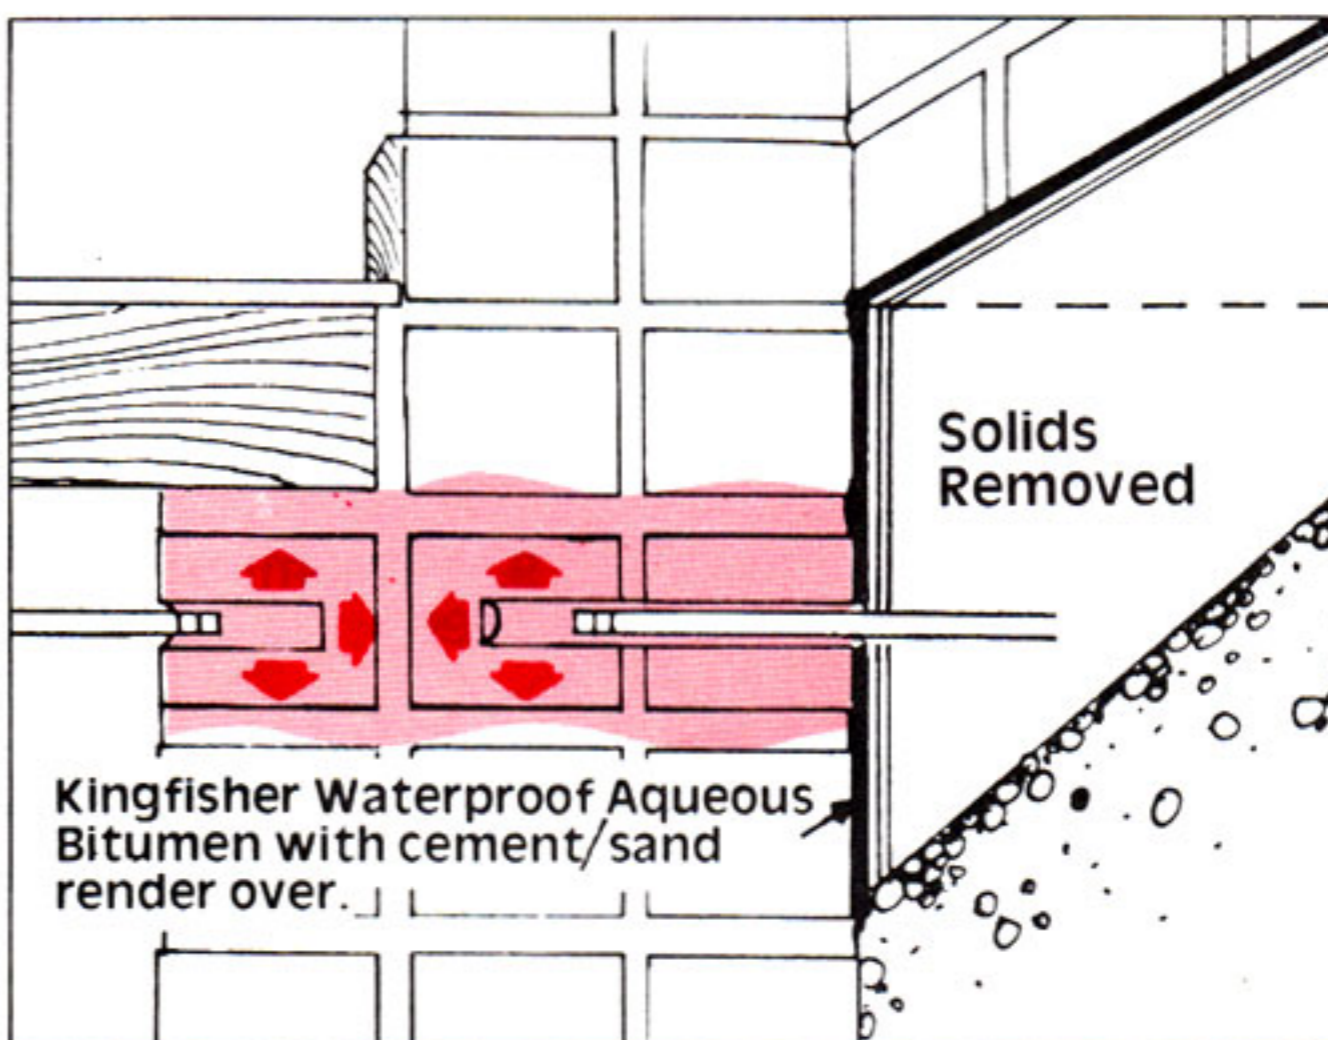
External ground level the same as internal floor level.

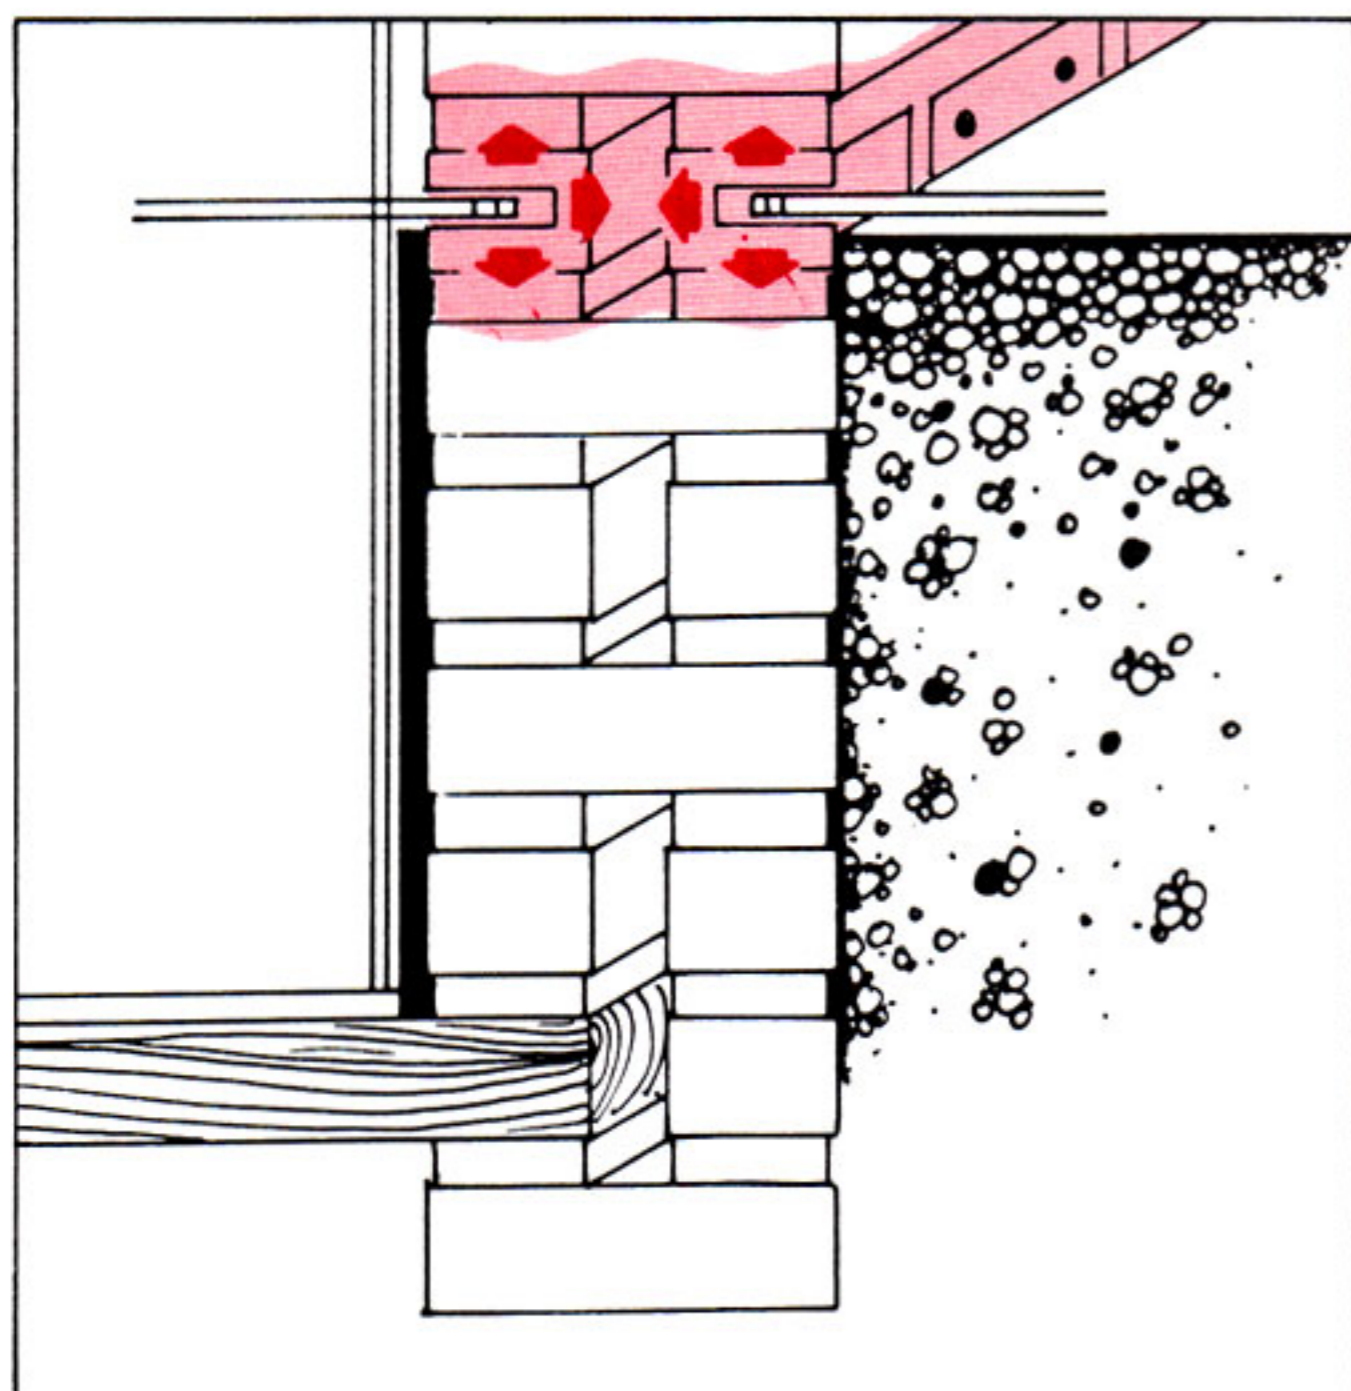
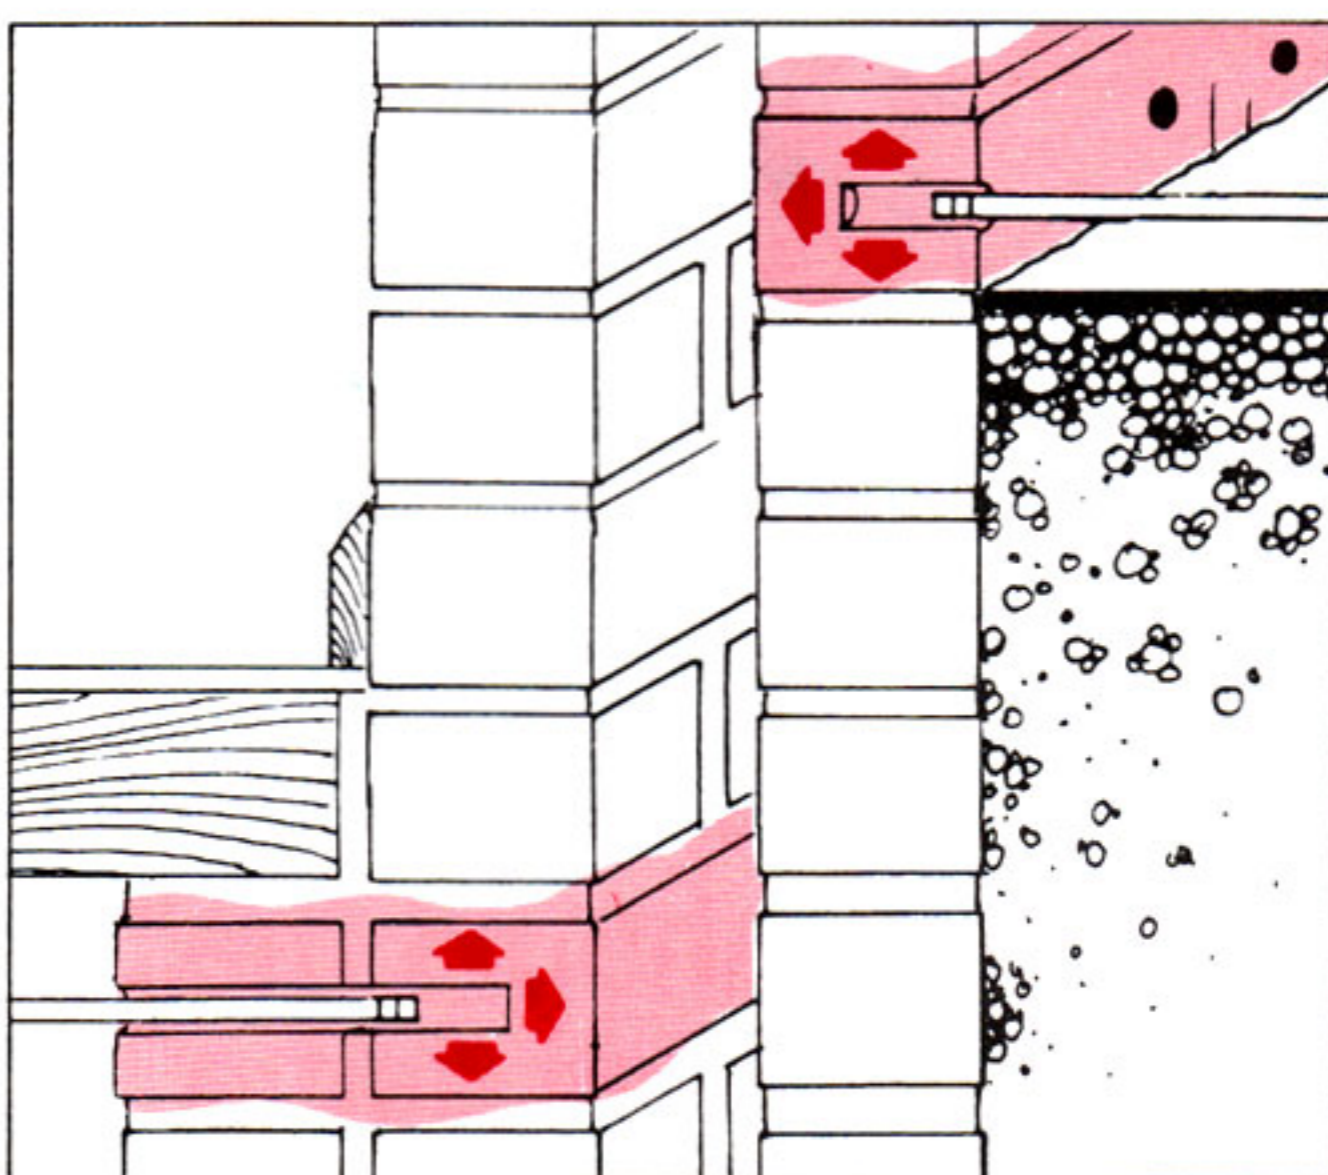
External ground level above internal floor level.
